COUNTRY AUTOMOTIVE

Invoice 1023098

Vehicle 2011 Lincoln MKX Base
 3.7 GAS
 2LMDJ8JK0BBJO0212
 6F50

Lincoln 2011 MKX 4X4 4-Wheel Total Alignment Current Measurements

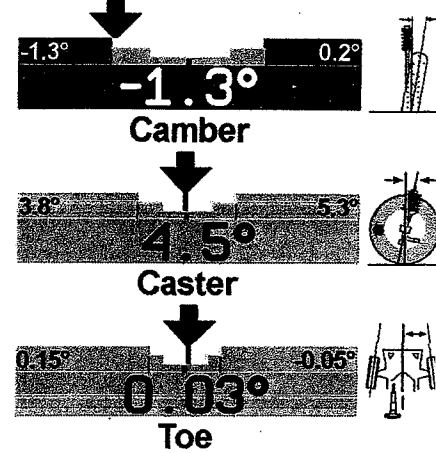
- Excessive Camber causes shoulder wear and poor handling.
- Negative Camber could cause road shock or poor ride quality.
- Excessive cross Camber could cause a pull to the left.

If vehicle steering wheel is not centered I would need to replace a strut bolt on the right front due to negative camber. This could also cause tire wear.
